THE GEOLOGY AND GEOMORPHOLOGY OF THE CORONET PEAK AND ARTHURS POINT LANDSLIDE COMPLEXES.

A thesis
submitted in partial fulfilment
of the requirements for the degree
of
Master of Science in Engineering Geology
in the
University of Canterbury
by
AMANDA JAYNE WILLETTS

University of Canterbury,
June, 2000.

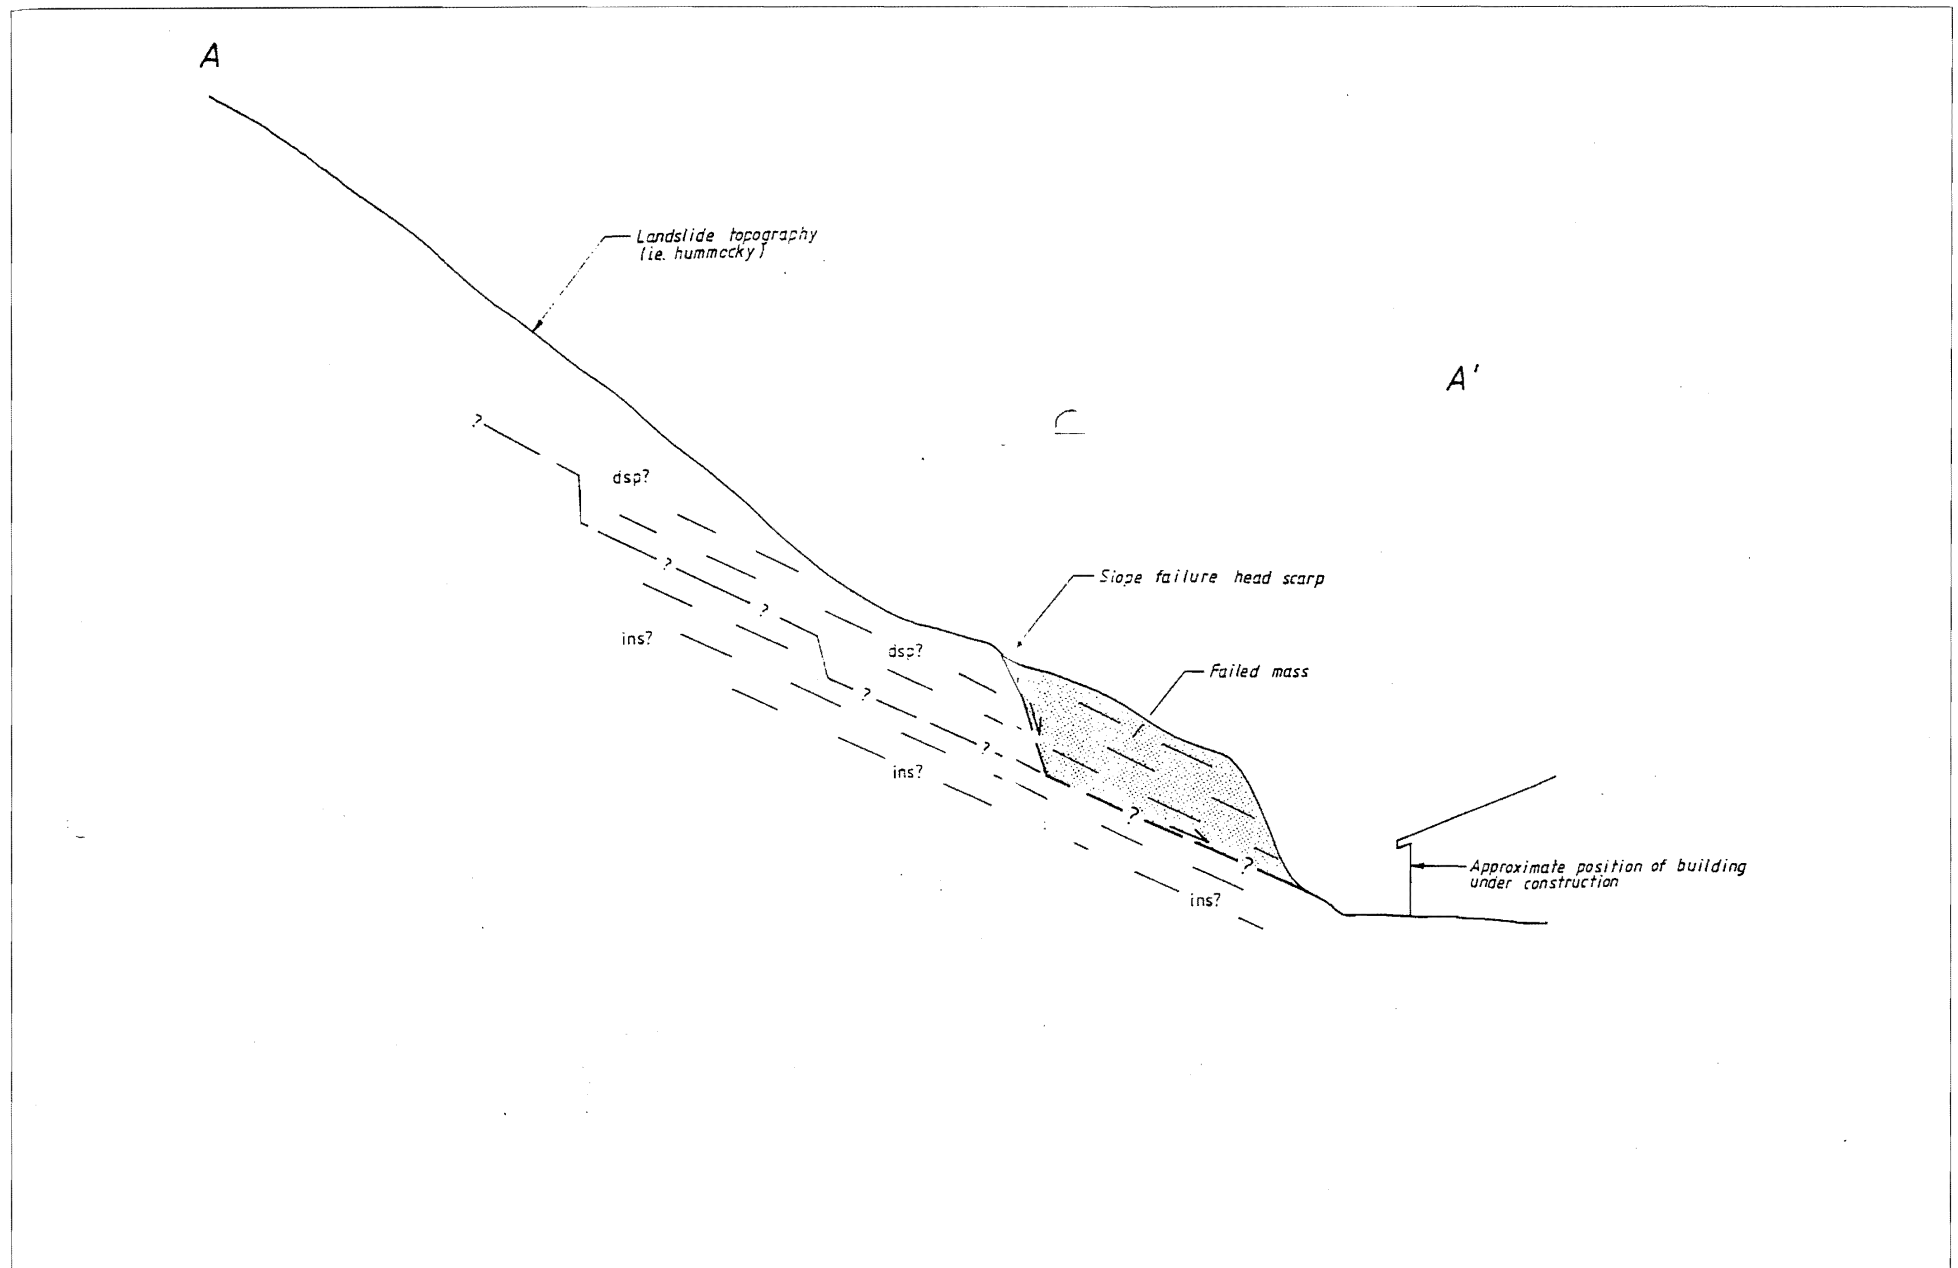
Fig 4.2 Cross-section of Coronet Plaza wedge failure.

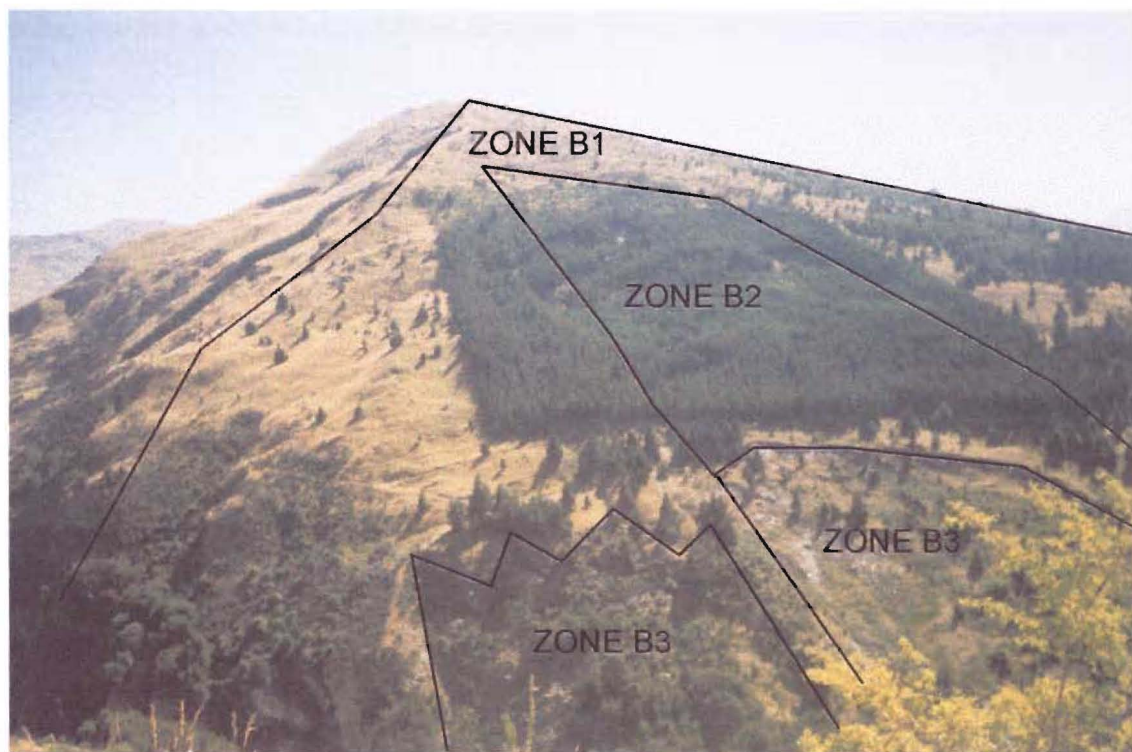
Fig 4.1 Zone B1, B2 and B3 of the Coronet Peak Landslide.

Zone B3 is the youngest and smallest reactivation of Zone B (Fig 4.1), made up of two small slides in the toe of the slide at the southern end. The headscarp of one of the slides (the one closet to the main headscarp of Coronet Peak Landslide (Fig 1.6a-map pocket; Fig 4.1) is prominent and joint and foliation-controlled.
